MEMORANDUM

To:	Valmichael Leos and Anne Foster, USEPA	Date:	February 21, 2014
From:	Wendell Mears, Randy Brown, David Keith, John Verduin, and John Laplante	Project:	090557-01.04
Cc:	Dave Moreira and Andrew Shafer, MIMC Phil Slowiak, IP		
Re:	San Jacinto River Waste Pits TCRA Armored Cap Enhancement Completion Report

This document provides a summary of enhancement activities with respect to the armored cap protective cover installed as part of the Time Critical Removal Action (TCRA) at the San Jacinto River Waste Pits (SJRWPs) Superfund Site (TCRA Site). Construction of armored cap enhancements for protective cover occurred from January 17 through 27, 2014; inspection of material gradations in the armored cap enhancement areas was completed on February 13, 2014.

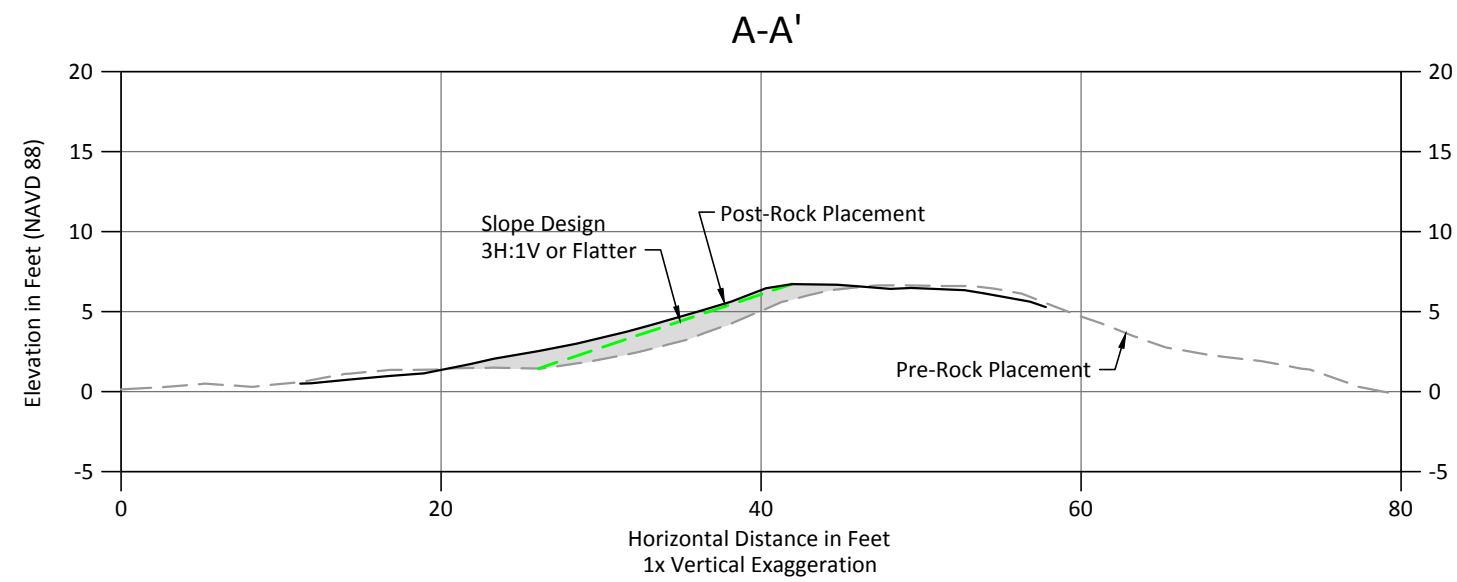
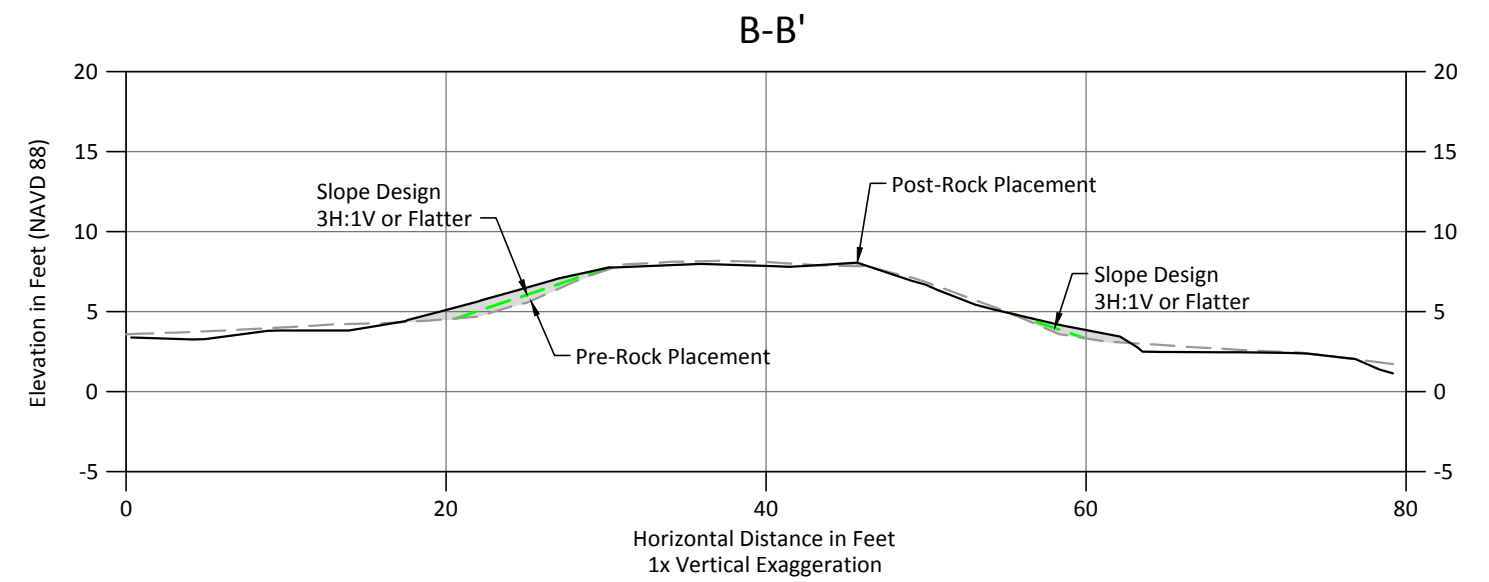
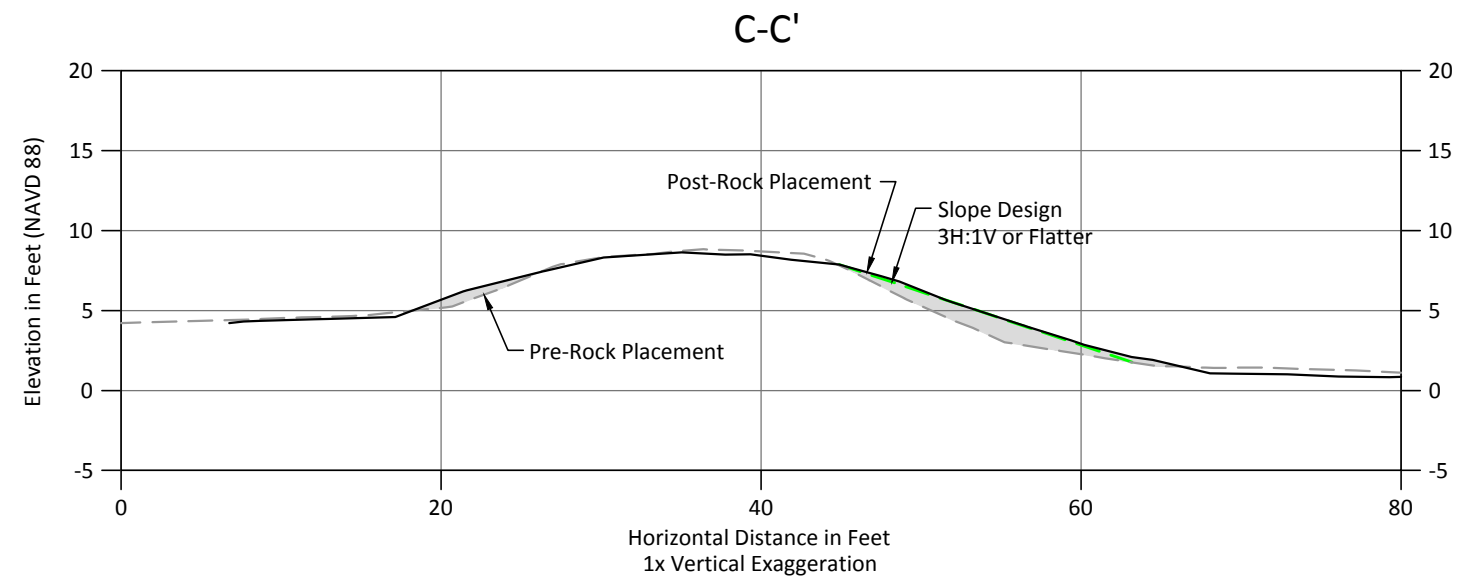
Figure 2 Cross Sections – Armored Cap Rock Enhancement (A-A', B-B', C-C')

Before completing an enhancement area and moving to the next, the post-enhancement slopes were field-measured for 1H:3V or flatter slopes at approximately 20-foot intervals using marked wooden boards placed horizontally and vertically atop the armored cap using a field level.

Construction proceeded first on the South Berm, then on the Central Berm in a north-to-south direction on the Central Berm. There was no construction activity on Friday, January 24, 2014, due to safety concerns resulting from freezing rain which would have made transport of personnel and Armor Cap D rock treacherous. Armored cap enhancement construction was finished on Monday, January 27, 2014, and a post-construction topographic survey of the enhancement areas was completed on the same date. Figures 2 and 3 contain cross-sections of the enhancement areas; each cross-section displays pre- and post-construction topographic survey data, and a line depicting the target 1V:3H slope.

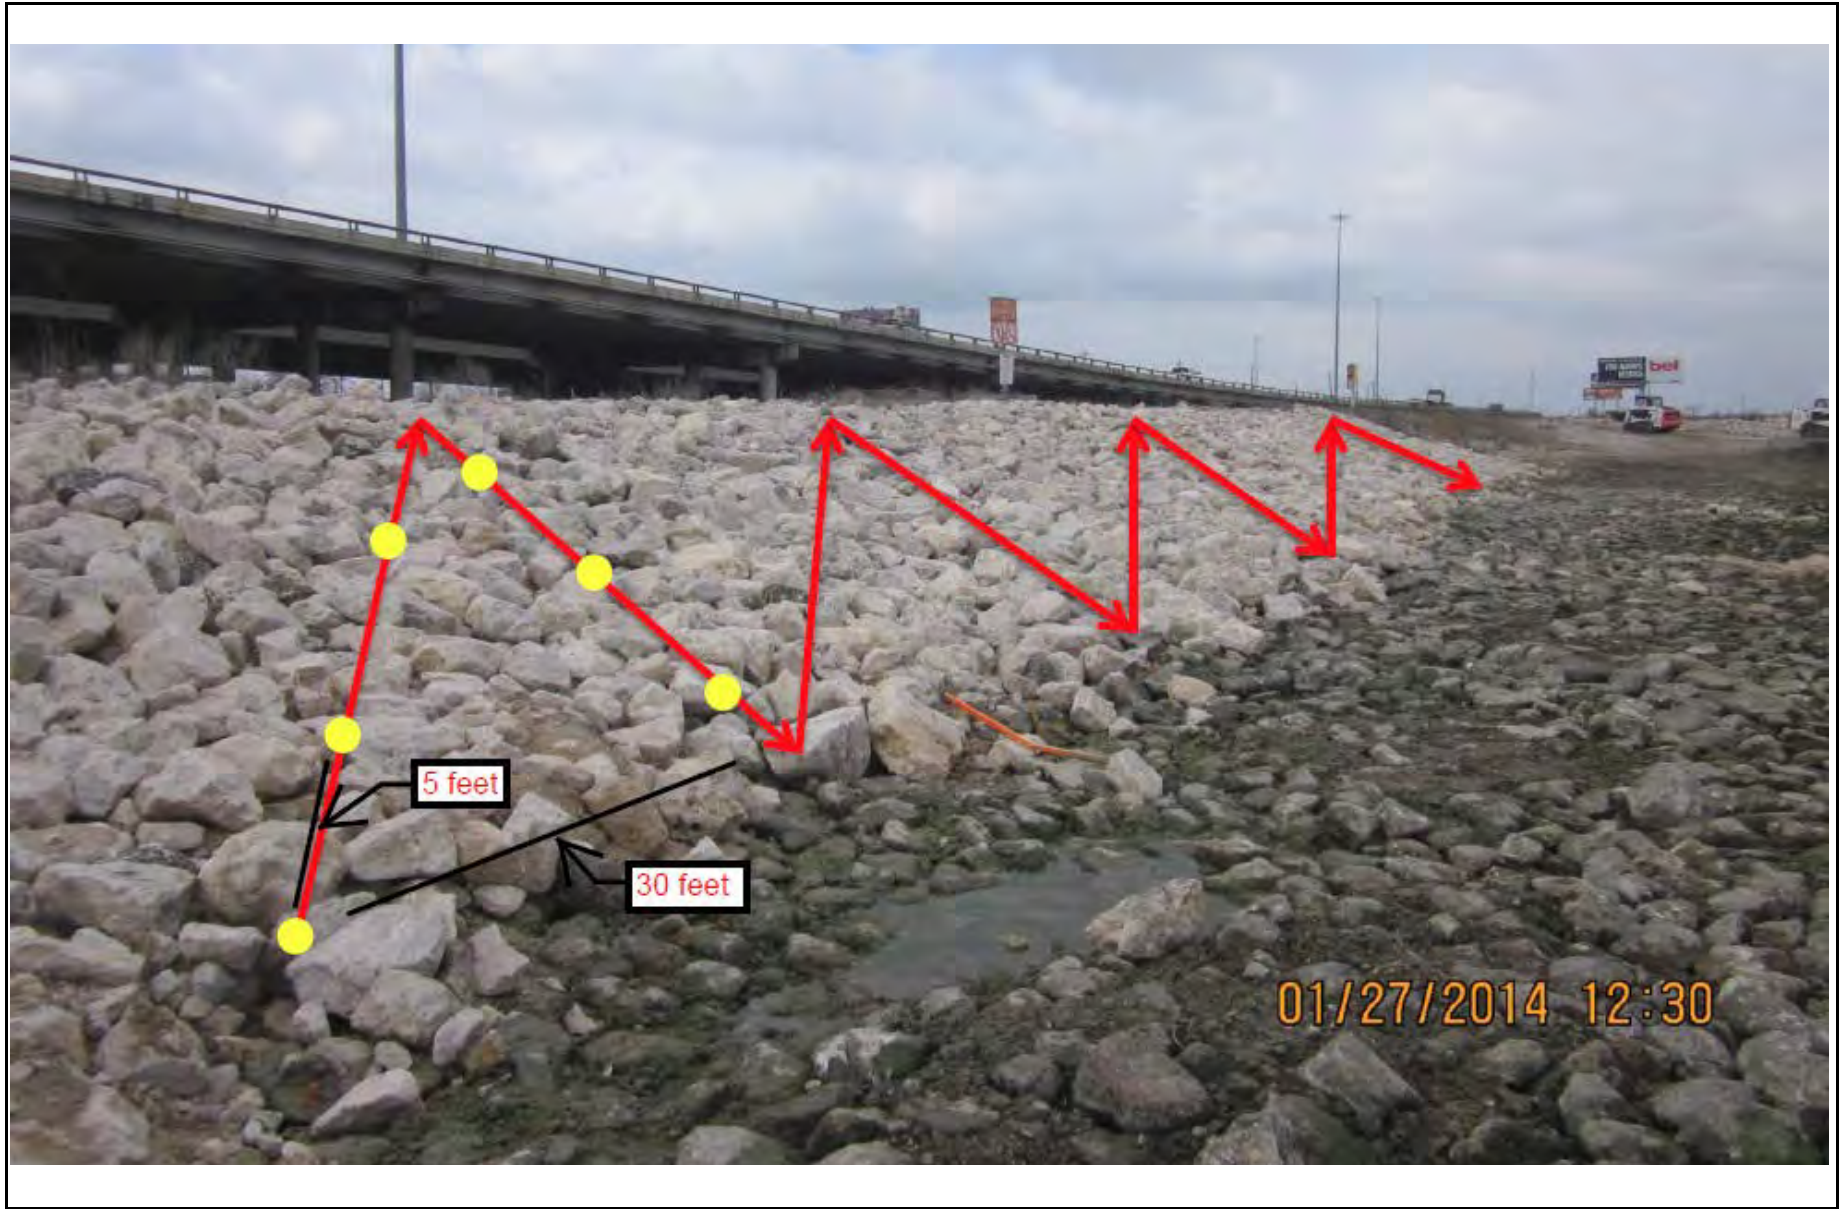
Figure 4 Typical Transect for Material Gradation Specification

Using this method, the particle sizes of the Armor Cap D rock was measured along three transects within the enhancement areas: the South Berm, the eastern slope of the central berm, and western slope of the central berm. The inspection was conducted in a zig-zag pattern across each transect (see Figure 4), measuring a rock size every 5 feet; 177 measurements were taken. Each rock was measured using a ruler across its intermediate axis, perpendicular to both the longest and shortest axes of the rock.

At each transect, the median measured particle size was 9 to 9.5-inches, greater than both the 6-inch D₅₀ specification for Armor Cap C rock recommended by USACE as part of their assessment (USACE, 2013) and the 8-inch D₅₀ for Armor Cap D rock that was used for the enhancements. This quality assurance review indicates that the Armor Cap D rock used for the armored cap enhancements was appropriately sized and did not undergo significant change during transport, handling, and installation.

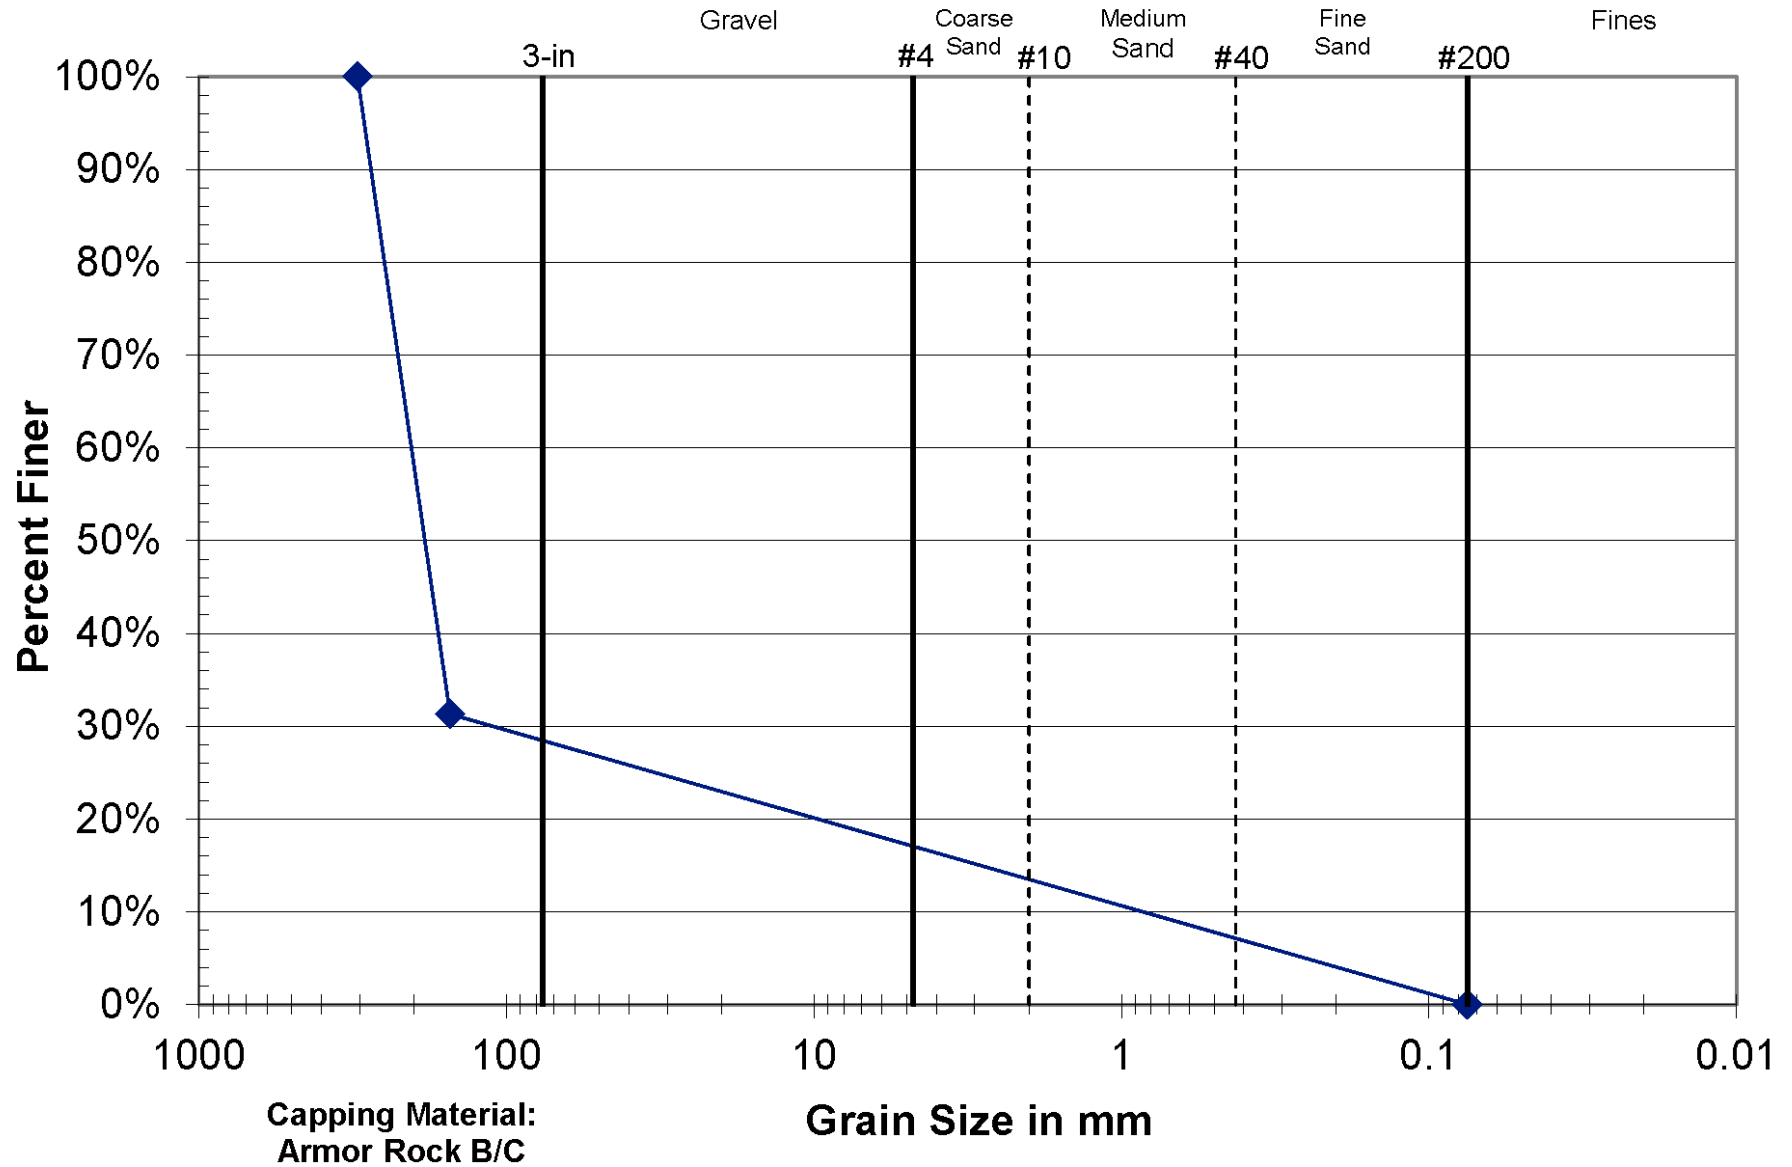
Figure 1

Gradation of Armor Rock B/C

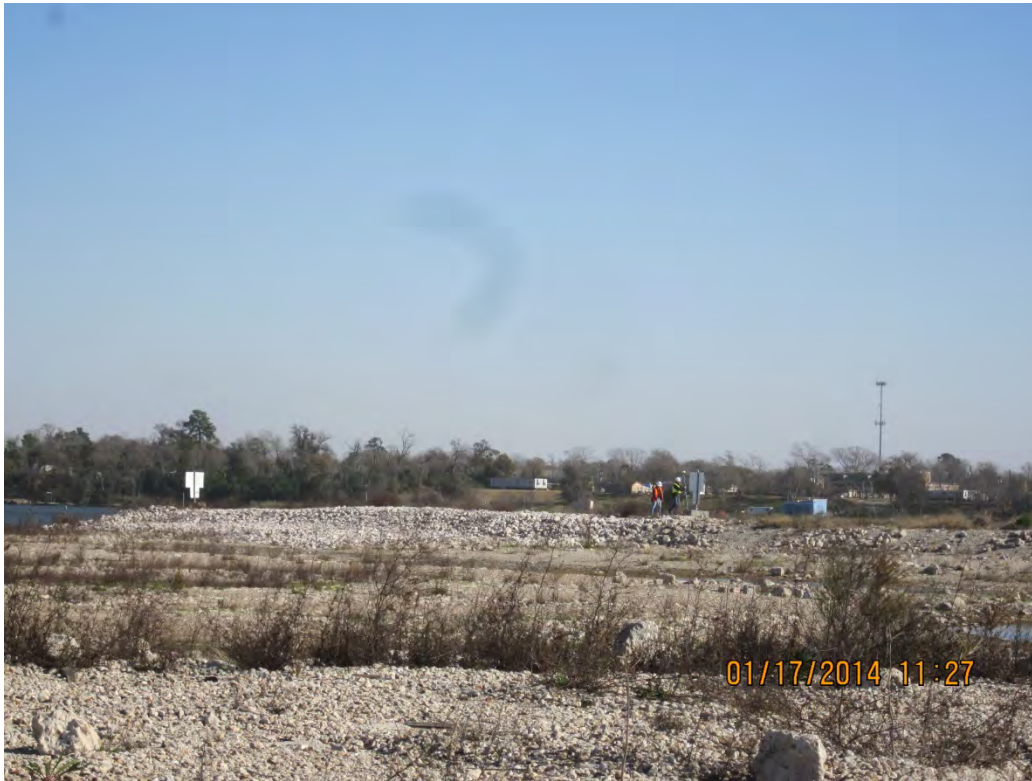
Photo 1 – Hydrographic Consultants perform pre-construction survey.

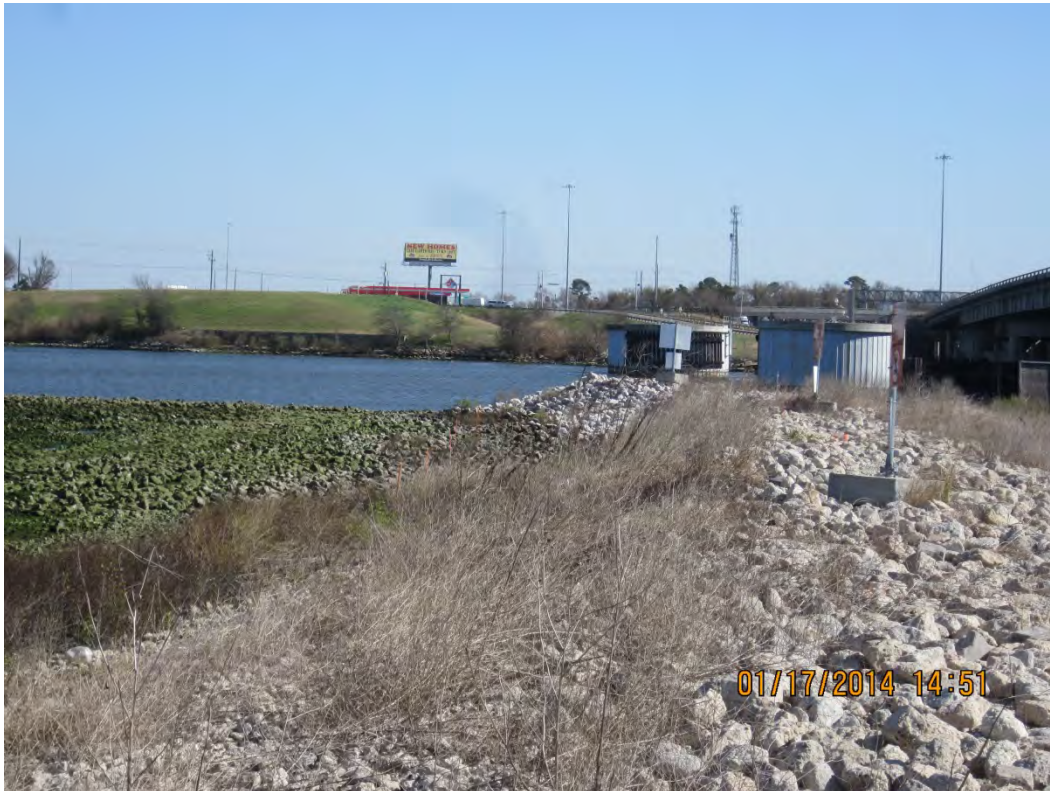
Photo 3 – Areas to receive armored cap enhancement marked along the South Berm.

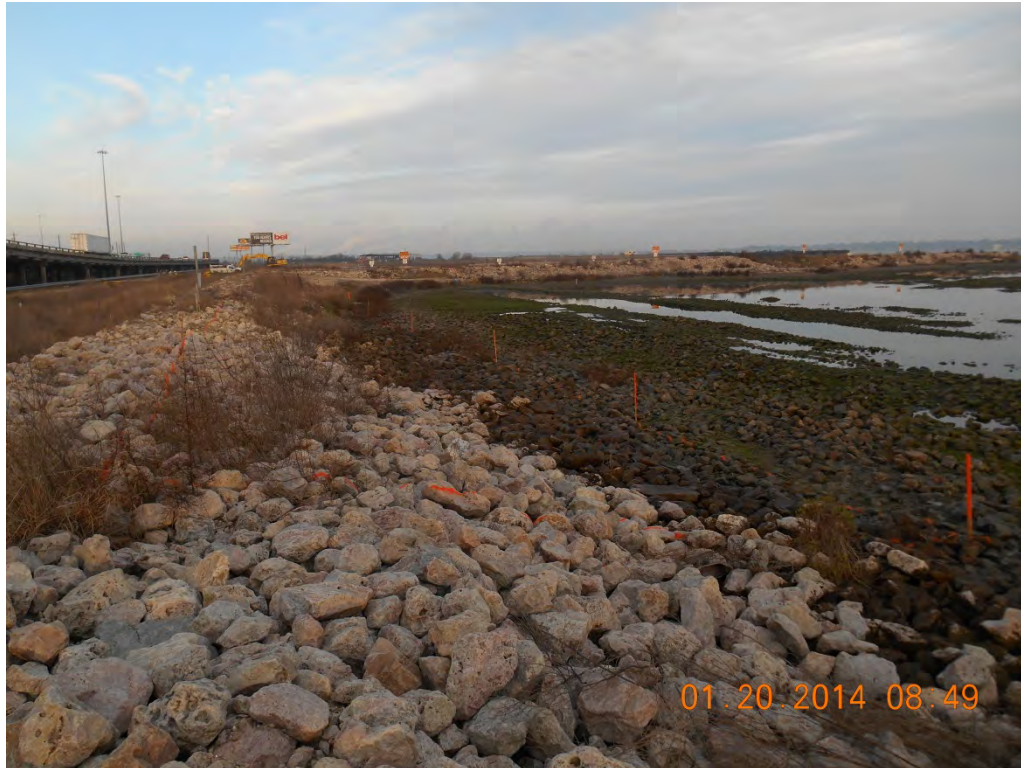
Photo 1 – Enhancement area on South Berm staked out before initiating rock placement.

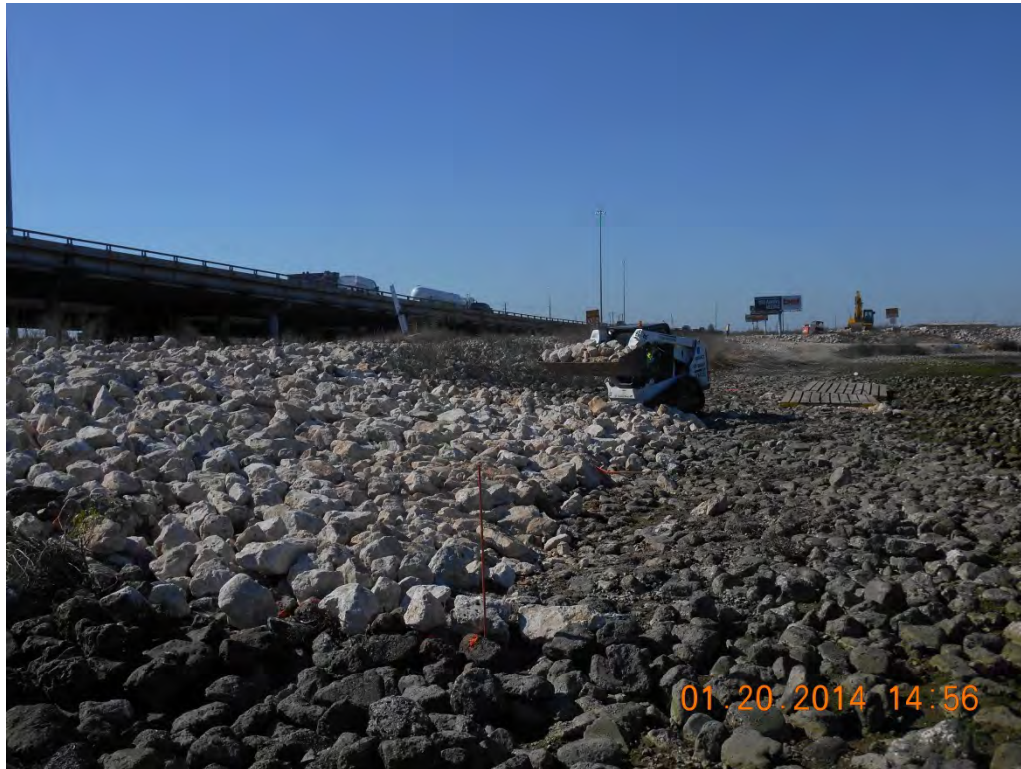
Photo 5 – Skidsteer placing Armor Cap D rock in the South Berm enhancement area.

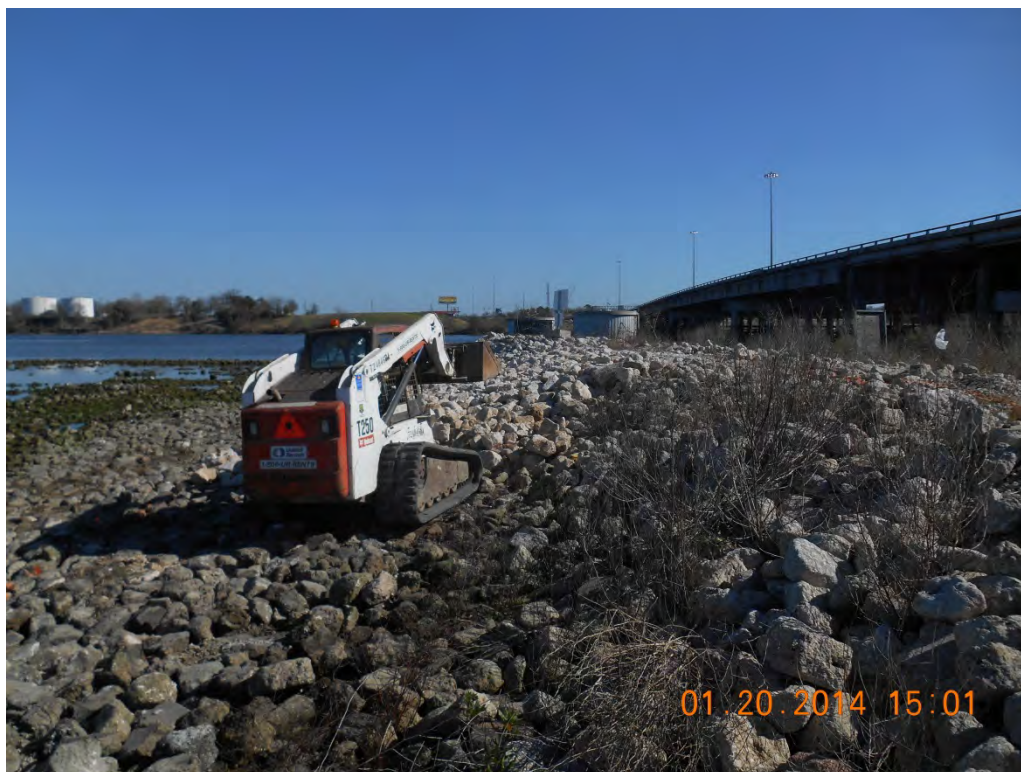
Photo 6 – Skidsteer placing Armor Cap D rock in the South Berm enhancement area.

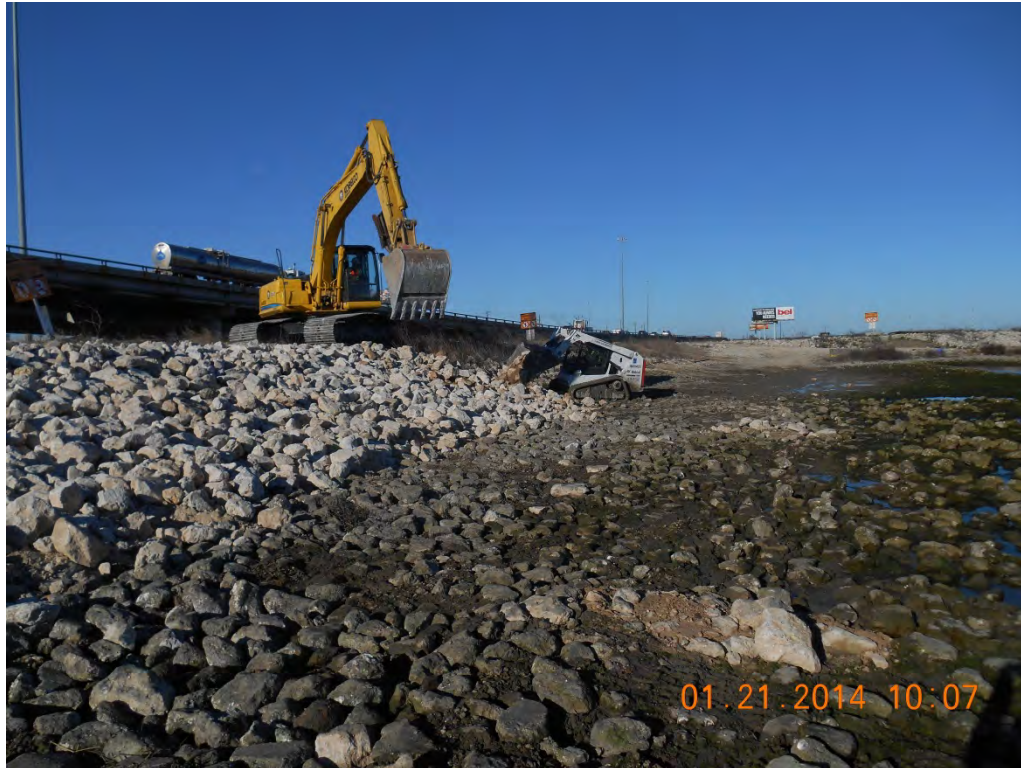
Photo 1 – Placing and grading Armor Cap D rock in the South Berm enhancement area.

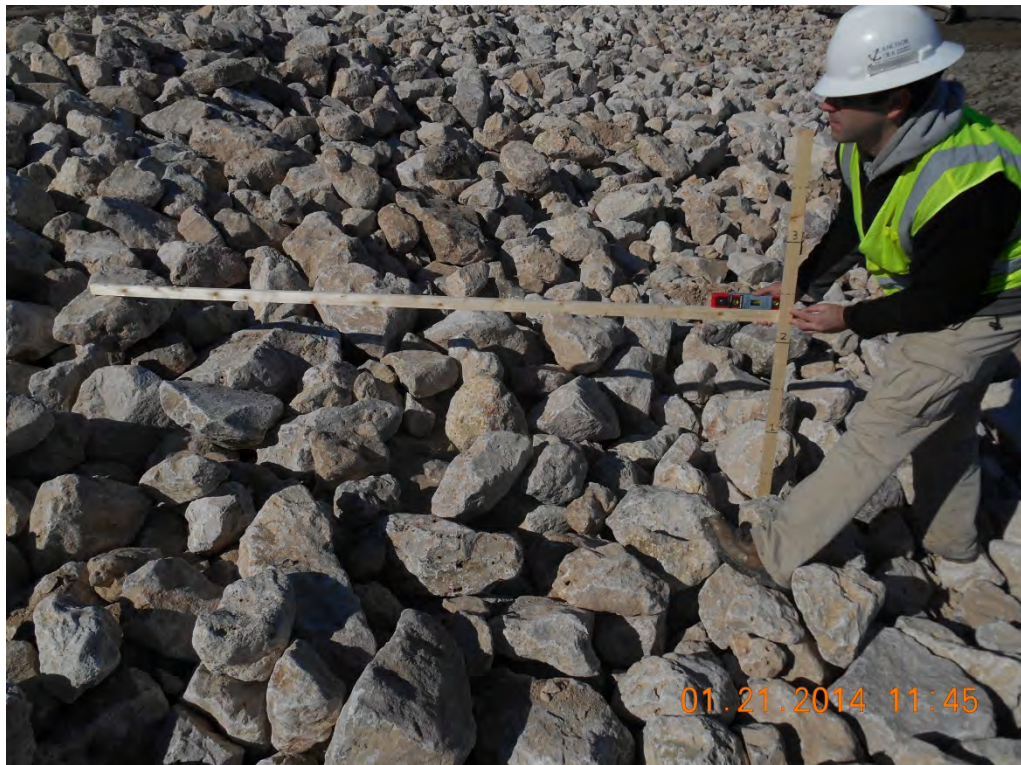
Photo 2 – Using a level to field-check the slope in the South Berm enhancement area.

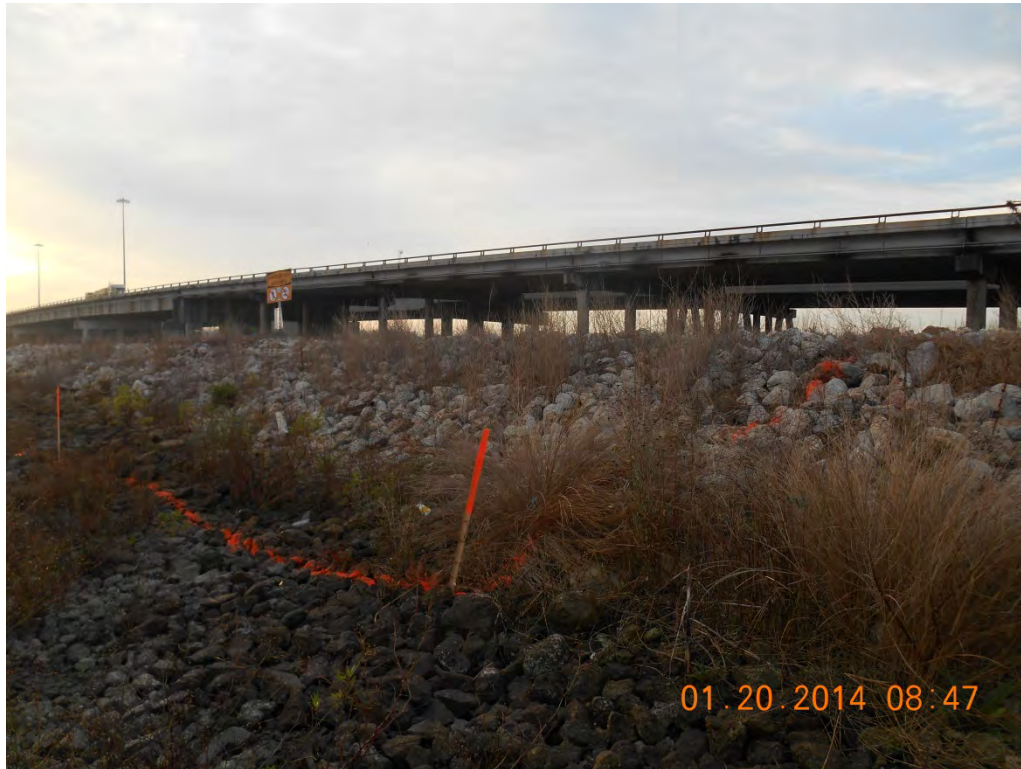
Photo 3 – Pre-enhancement slope of the South Berm.

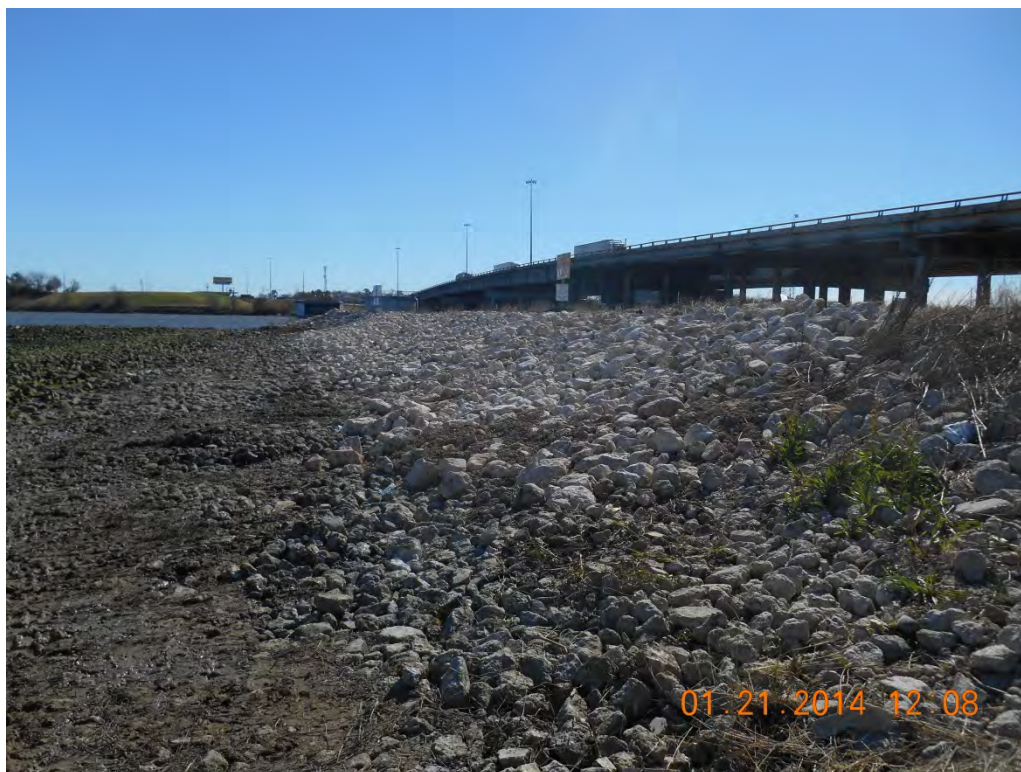
Photo 4 – Post-enhancement slope of the South Berm.

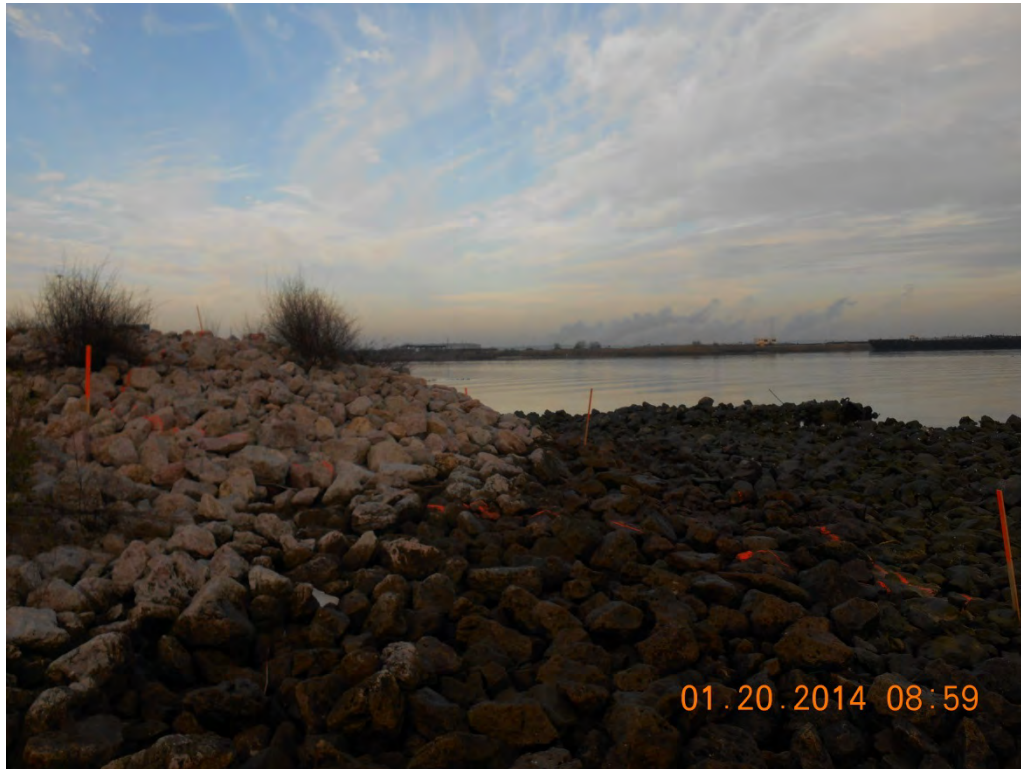
Photo 5 – Pre-enhancement slope of the north end of the Central Berm.

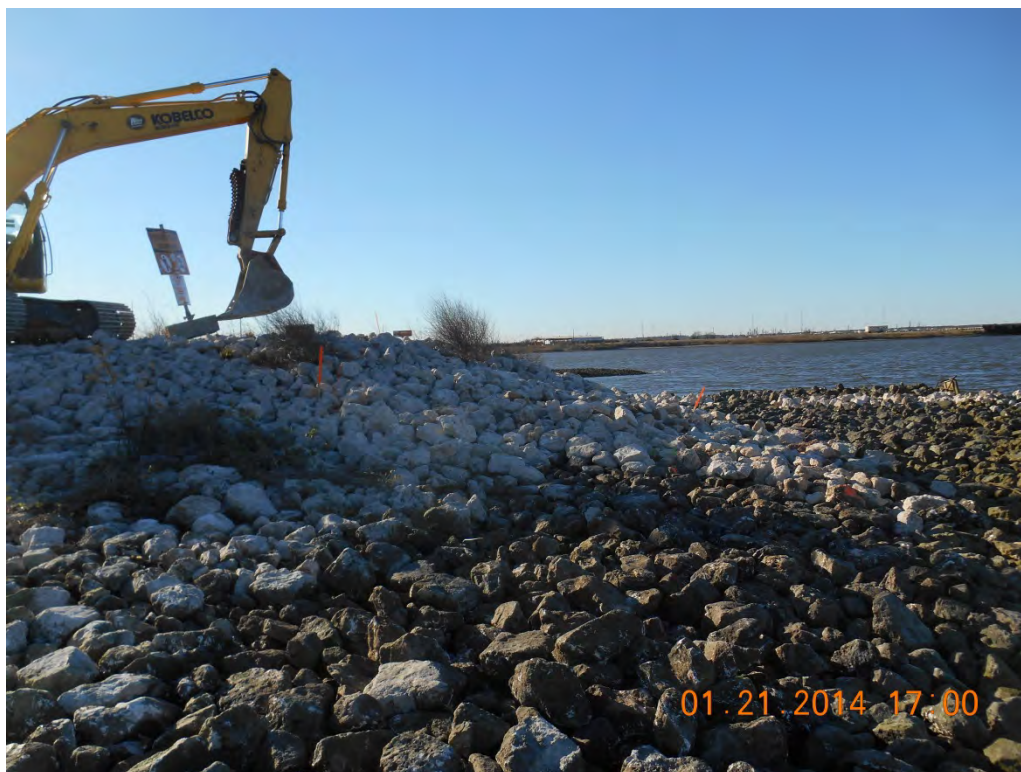
Photo 6 – Post-enhancement slope of the north end of the Central Berm.

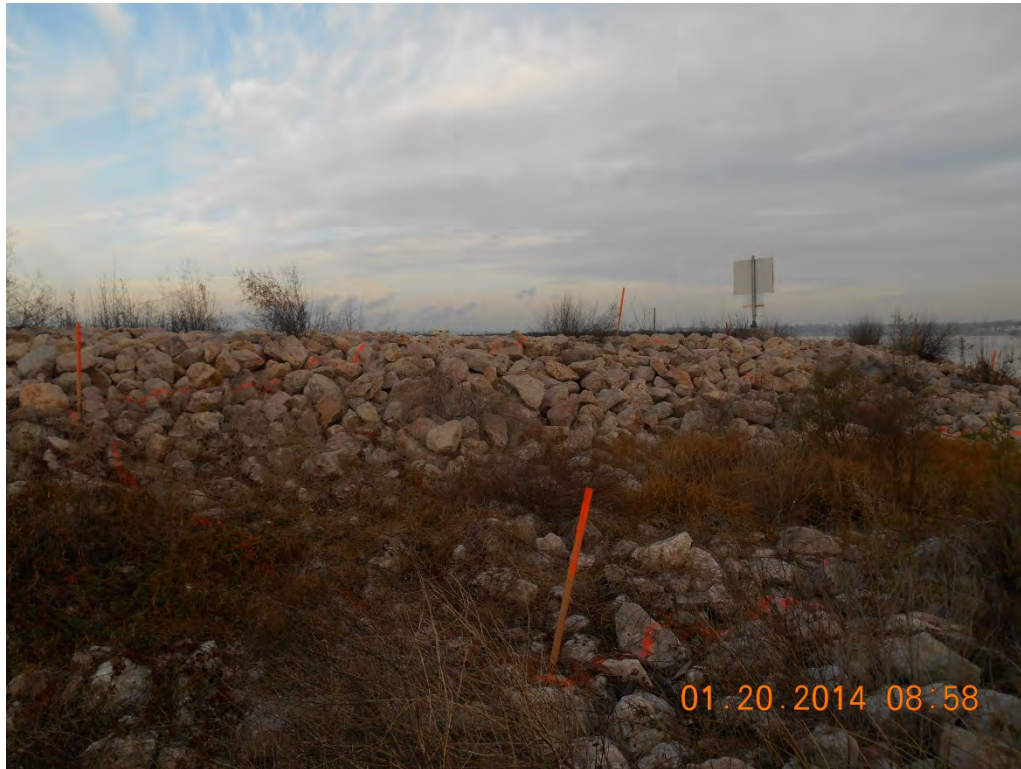
Photo 1 – Pre-enhancement slope of Area #3 on east slope of the Central Berm.

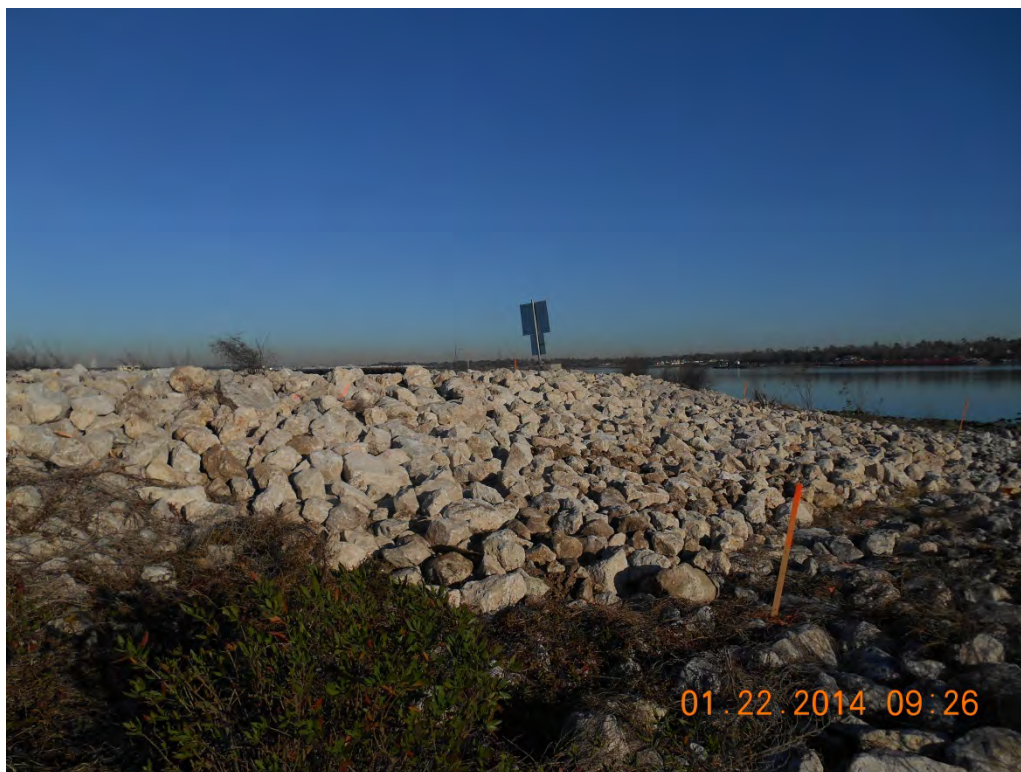
Photo 2 – Post-enhancement of Area #3.

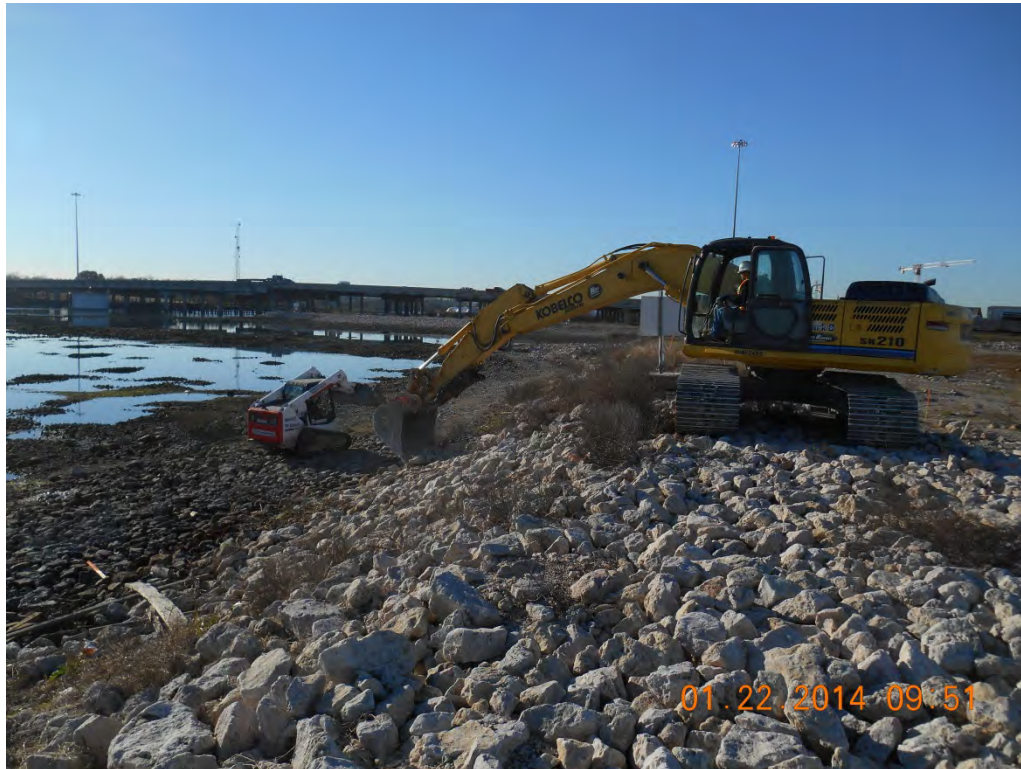
Photo 3 – Placing and grading Armor Cap D rock along east slope of the Central Berm.

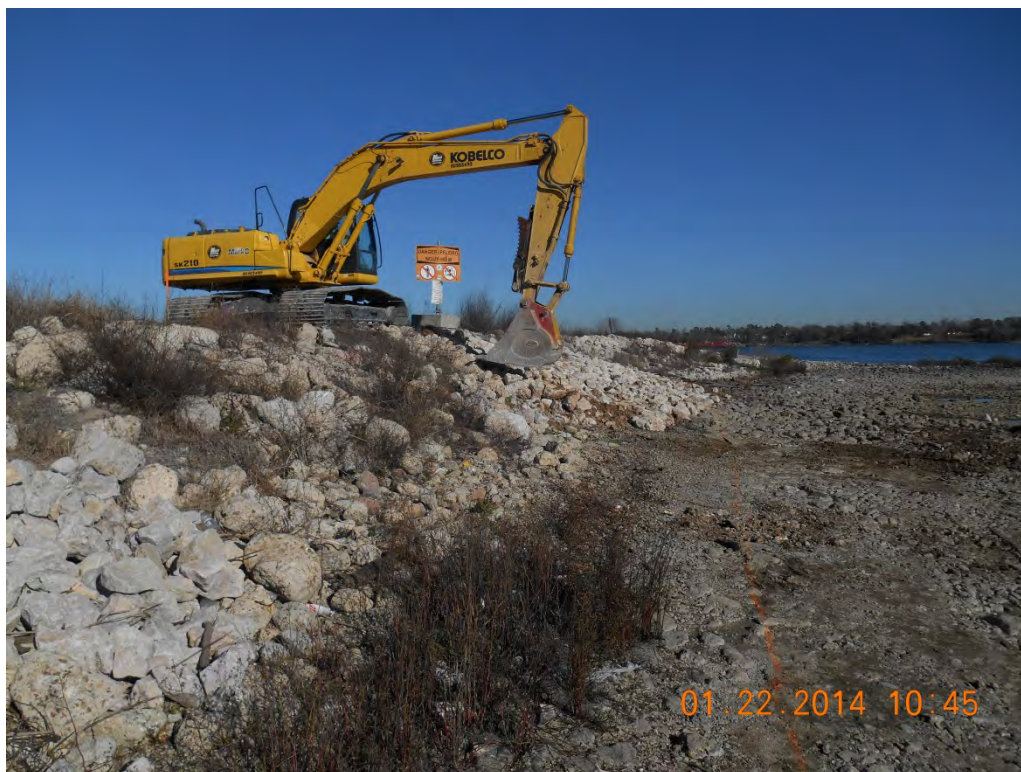
Photo 4 – Grading Armor Cap D rock along east slope of the Central Berm in Area #4.

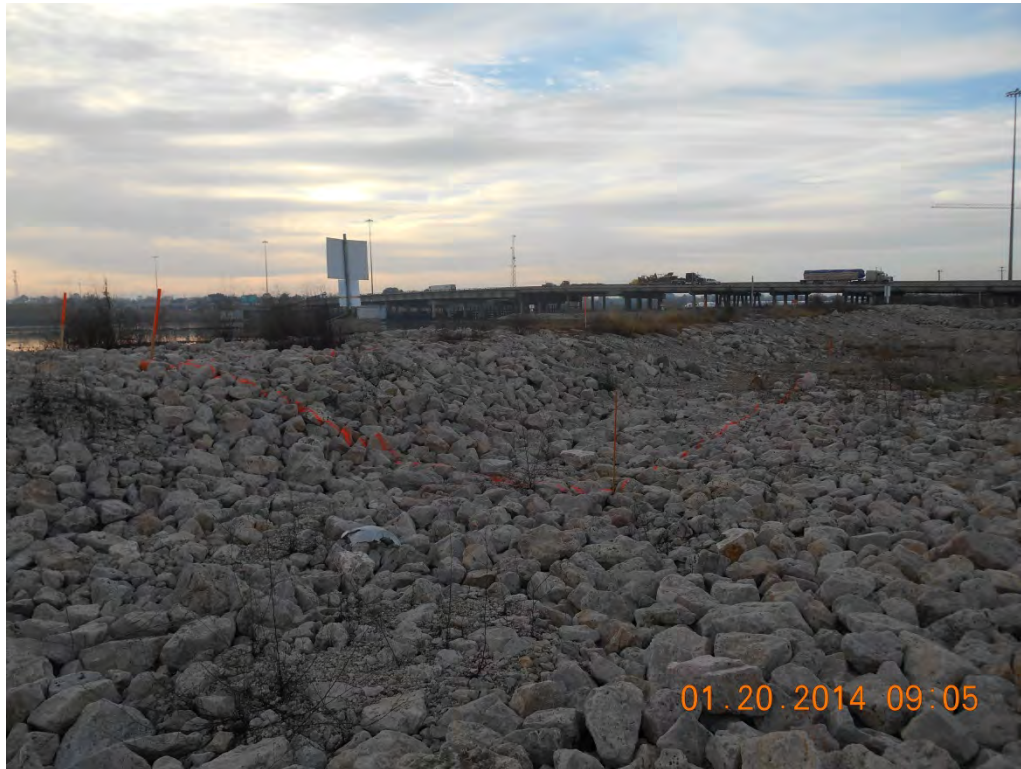
Photo 5 – Pre-enhancement slope of Area #6 on the western slope of the Central Berm.

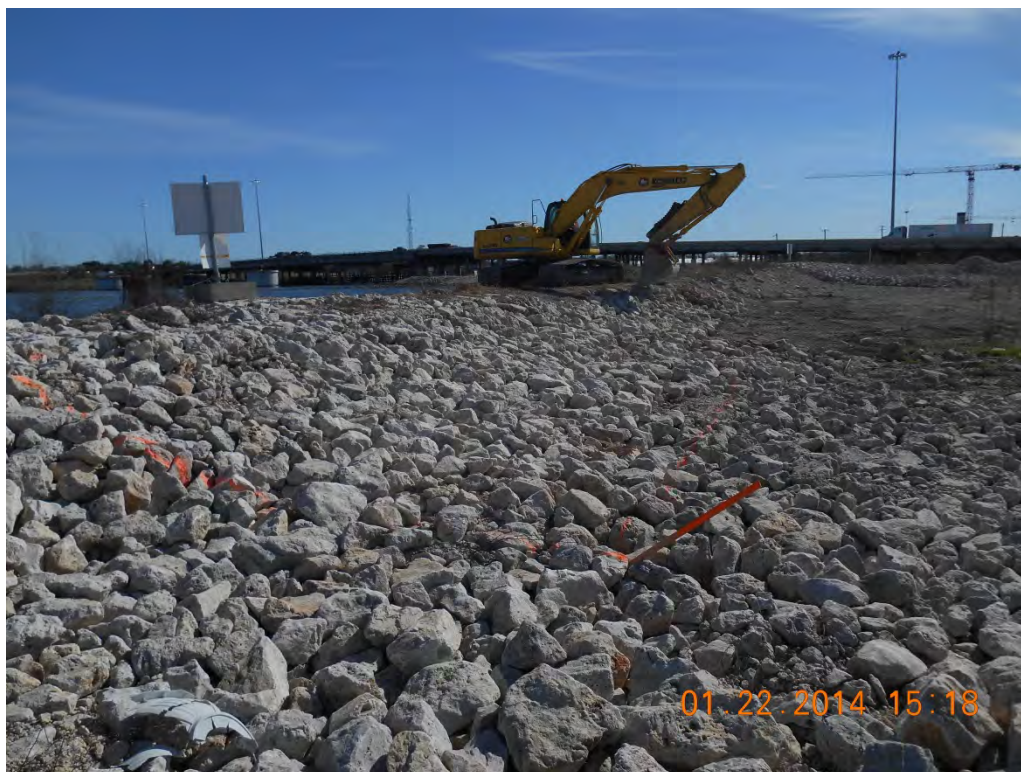
Photo 6 – Post-enhancement slope of Area #6 on the western slope of the Central Berm.

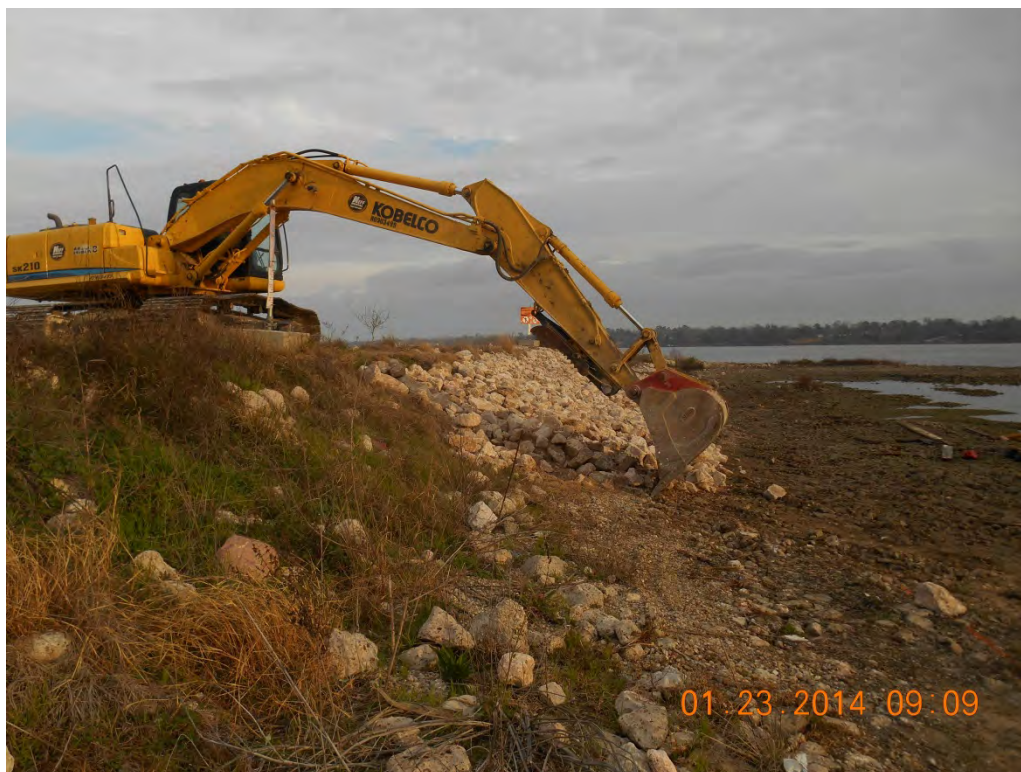
Photo 2 – Grading Armor Cap D rock on the eastern slope of the Central Berm in Area #4.

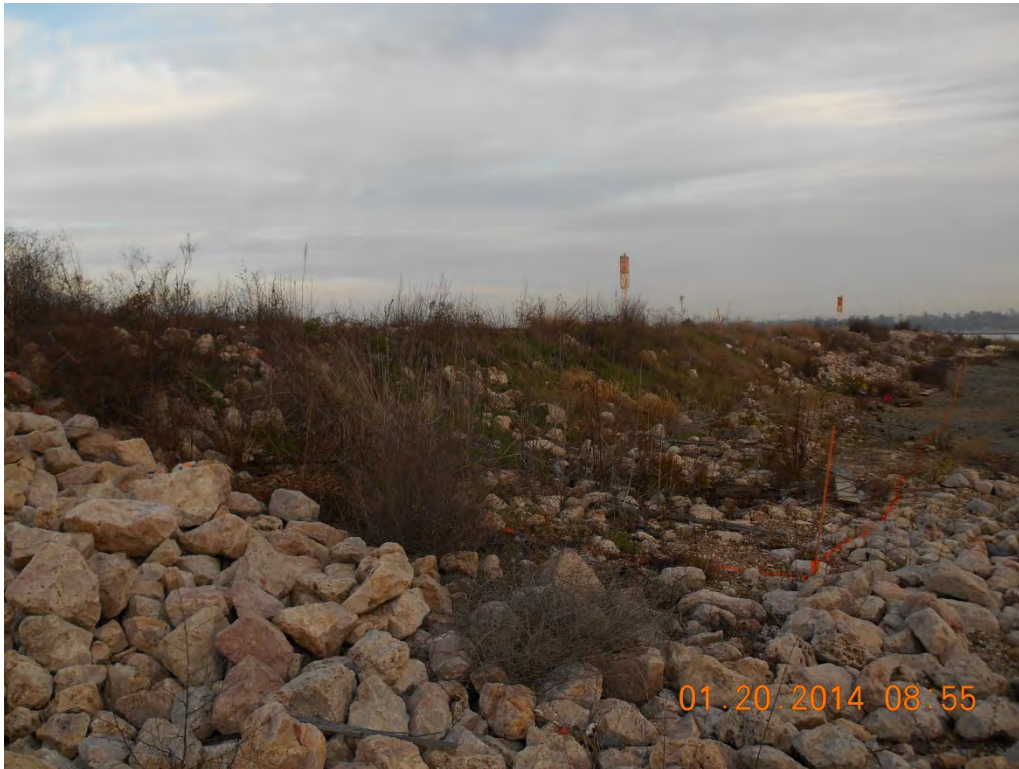
Photo 3 – Pre-enhancement slope of Area #4 on the eastern slope of the Central Berm.
